CAMERON RESERVOIR NO. 2 DAM

DEKALB COUNTY, MISSOURI

**PHASE 1 INSPECTION REPORT
NATIONAL DAM SAFETY INSPECTION**

JULY 1979

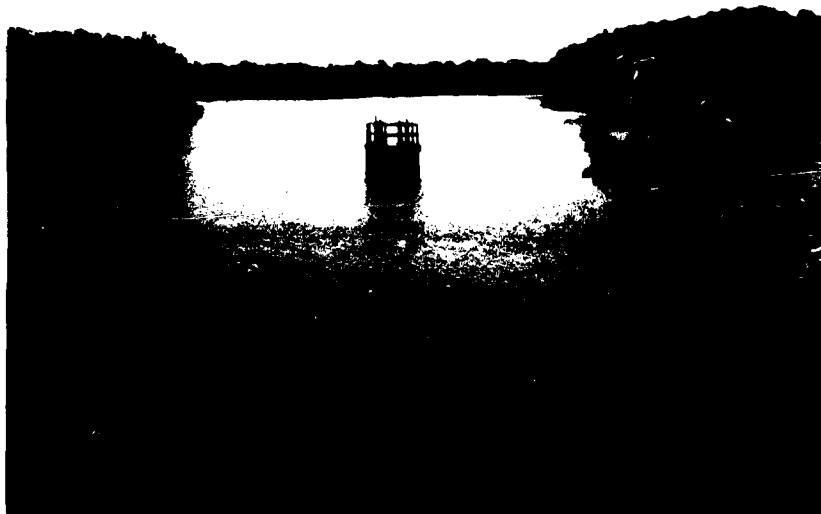
PHOTO 4: INTAKE STRUCTURE

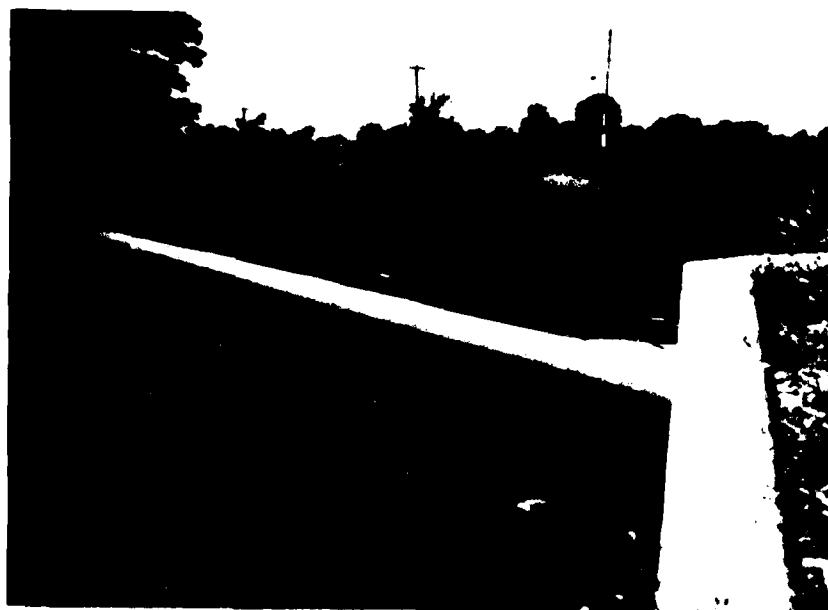
PHOTO 5: SPILLWAY CREST
